Lunker Federal #2-33-4H

Weekly Inspection Report

April 1 and April 4, 2013

Prepared for:

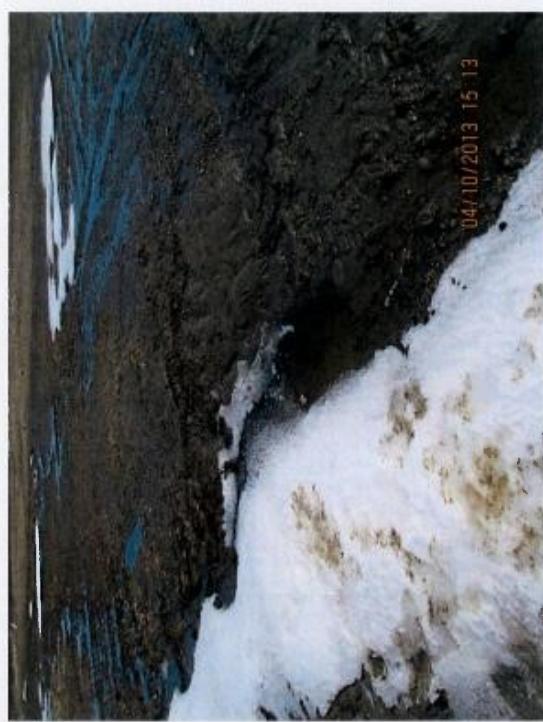
Figure 43.

General conditions of the Wildlife Management Area (WMA) during this survey included no movement of water due to ambient temperature and the fact that very little snow remained in the area. Pools of iced over water could be found. No visible petroleum sheen was observed at any location. Some biological mass was observed within the RV park. Figures 42 and 43 record the observed biological mass observed within the RV park.

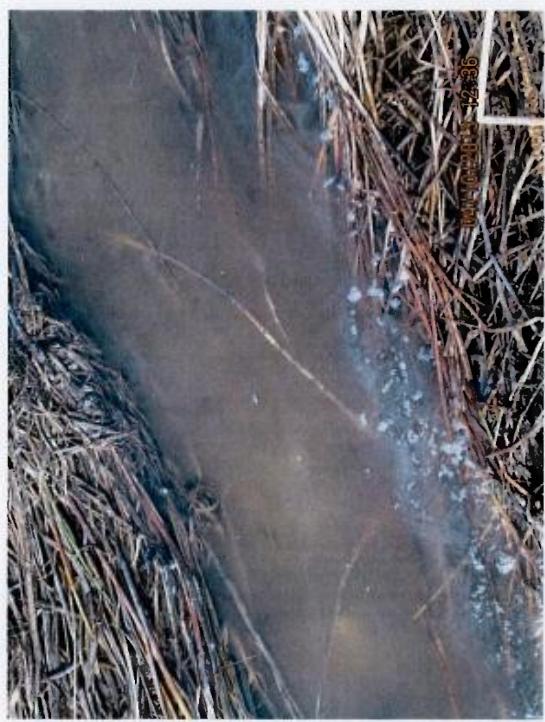
Figure 55.

Biological mass was observed north and east of the pad (Figures 55 and 56).
